Southern Sandoval County Arroyo Flood Control Authority 2002 Report of Activities

Y-Channel and Area B Evaluation

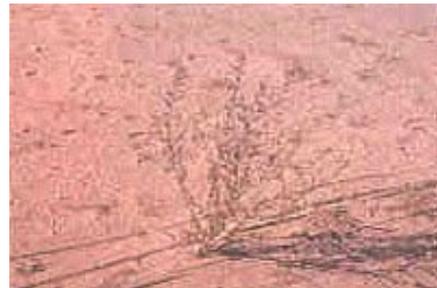
The transplants at the Y-Channel site had a very limited survival rate. The following species were surviving but have put on only limited growth since they were planted: Sumac, Seepwillow, Rabbitbrush, Desert Willow, Sage and Wolfberry. Only two Wolfberry plants were alive, and the remaining species had averaged a 20% survival rate.

Y-Channel – Seepwillow

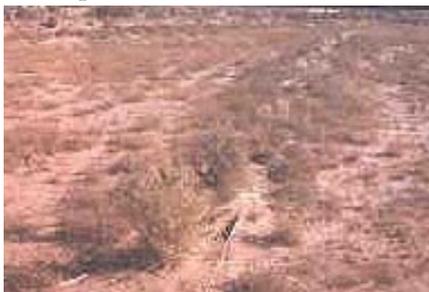
The transplants at the Area B site also had very limited survival and growth. The following species are surviving: Wolfberry, Saltbush, Sand Sage and Fringed Sage. Of the surviving plants, the Saltbush appears to be doing the best. The survival rate of the transplants at Area B has averaged about 15%. These plants have become established and have a good chance to mature and reproduce.

Fourwing Saltbush – Site B

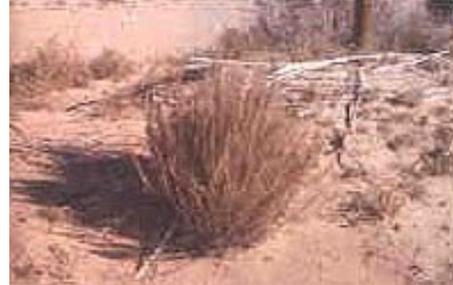
Area B – Sagebrush

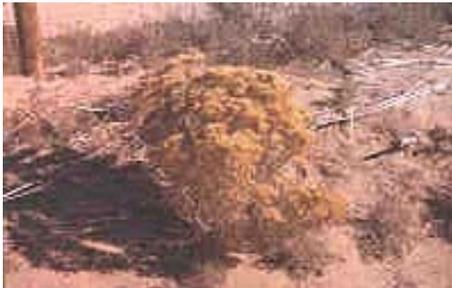
Area B – Rabbitbrush
